Philips Senseo II 7810 Coffee Maker - Capacitor on Printboard replacement

This guide helps to solve a heating problem of a Philips Senseo II (7810) by providing an overview of how to replace the capacitor on the printboard.

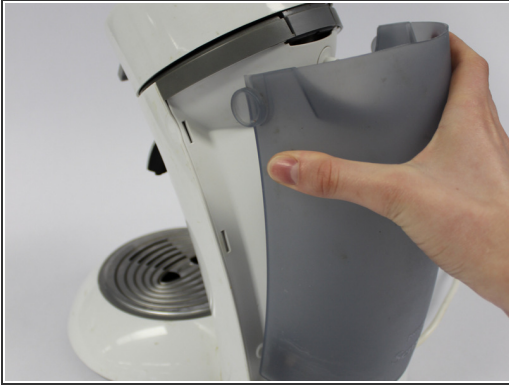
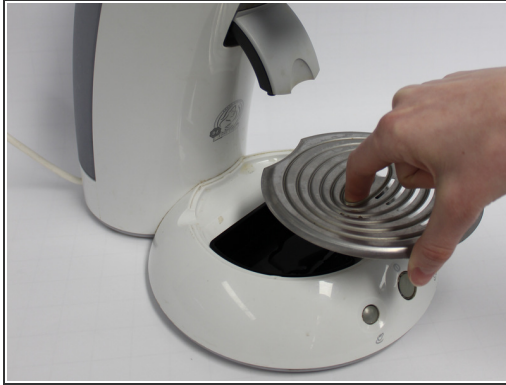
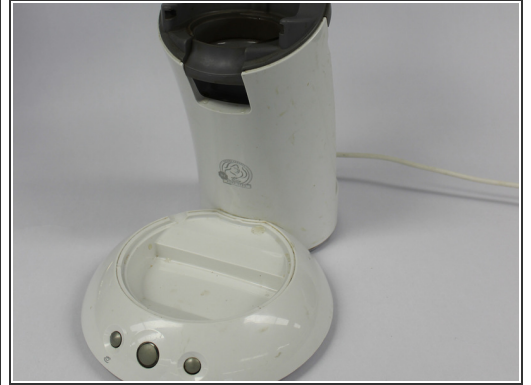
Step 1 — Replacing the capacitor on printboard

- Remove the detachable components of the coffee maker:
 - unplug the product;
 - empty the water container and remove it from the coffee machine;
 - remove the cup tray and drip tray;
 - remove the pod holder and coffee outflow unit.

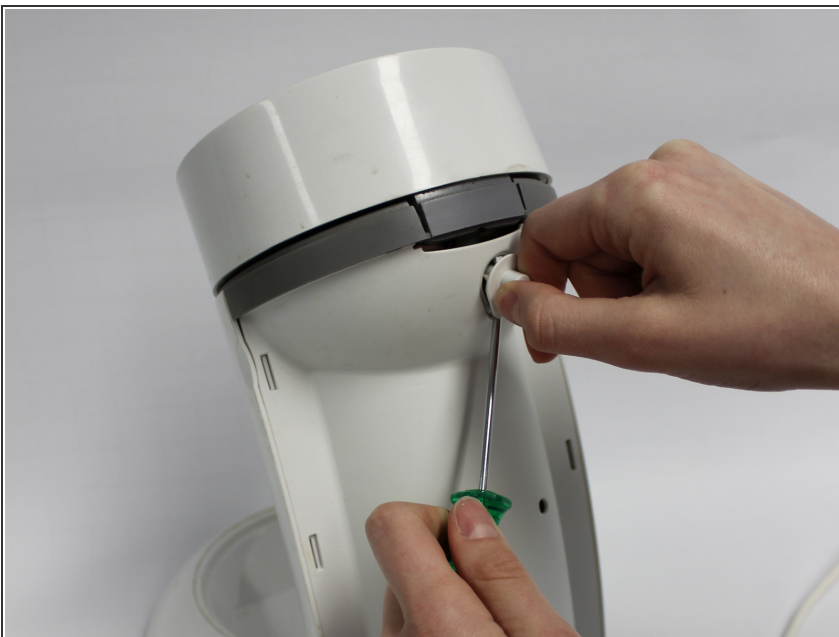
Step 2

- Remove outflow valve by putting a flathead screwdriver in the gaps and use this as a lever.

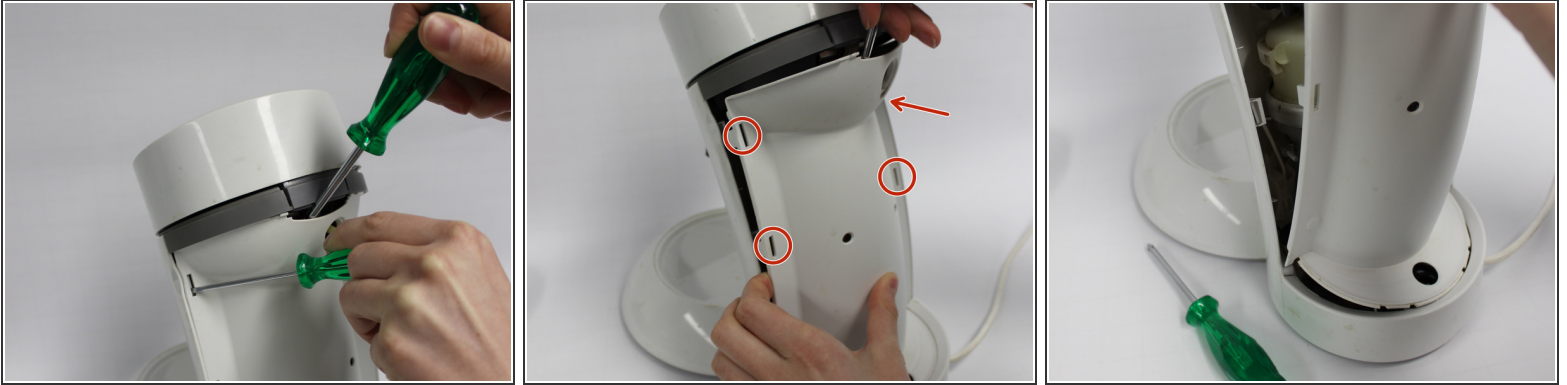
Step 3

- Remove back panel by:
 - inserting (flathead) screwdriver in the top and pressing this against the snap-fit;
 - pressing screwdriver on left side against the snap-fit simultaneously;
 - rotating back panel whilst pressing against the snap-fits to loosen the panel until it is no longer connected on that side;
 - pressing screwdriver on right side against the snap-fit and removing back panel altogether.

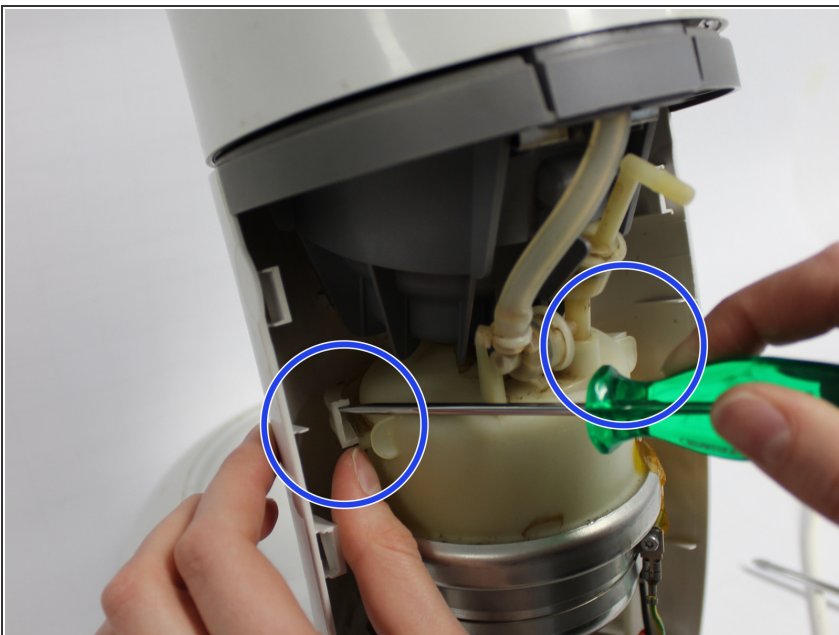
Step 4

- Remove side clamps to make the boiler accessible by pressing the plastic hooks (left and right) to the side.

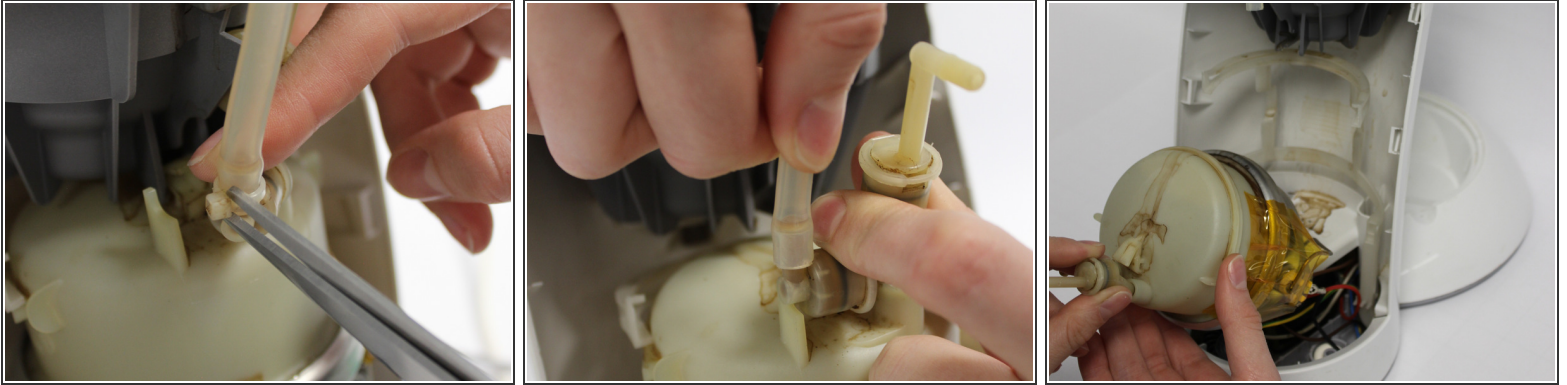
Step 5

- Access the inner housing of the coffee maker by:
 - removing tie wrap from three-way valve with a pair of scissors;

- disconnecting the three-way valve from the hose. Beware of possible breaking of the bottom tube of the valve that is inside the boiler opening;

- tilting the boiler, towards you (away from the inner casing).

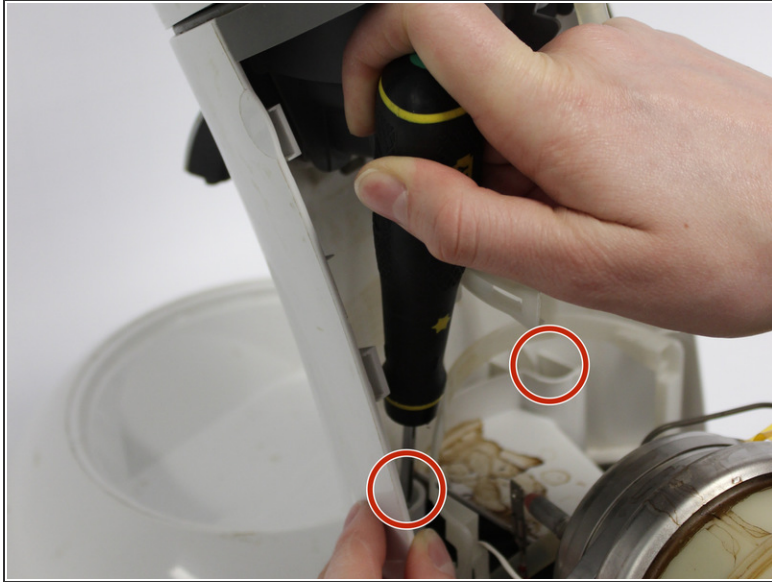
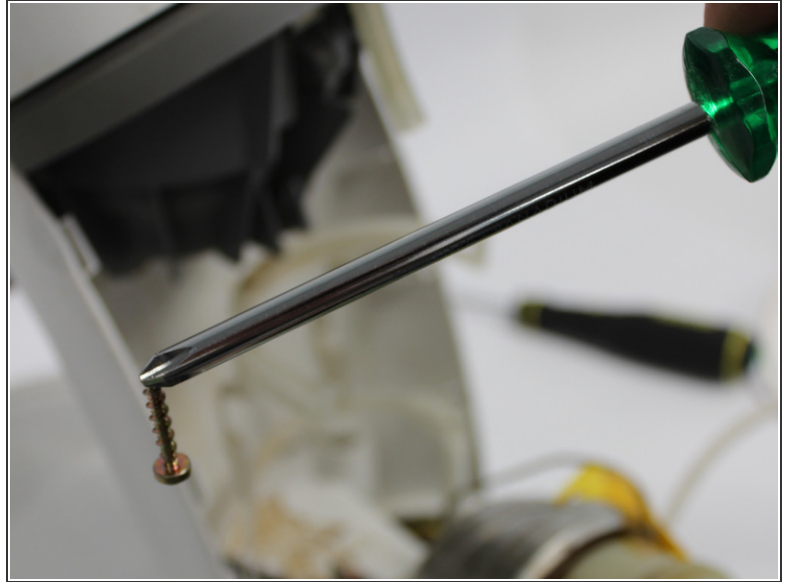
Step 6

- Remove the 2 screws from within the housing, using a Torx T10 screwdriver.

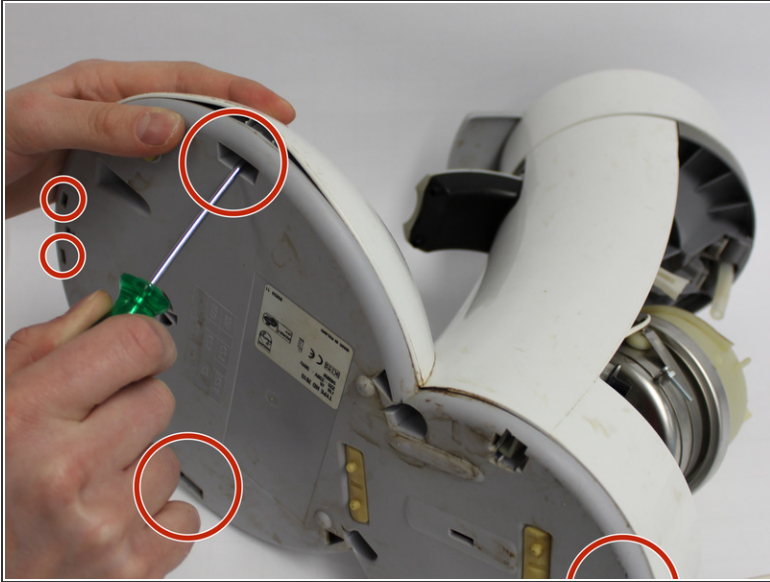
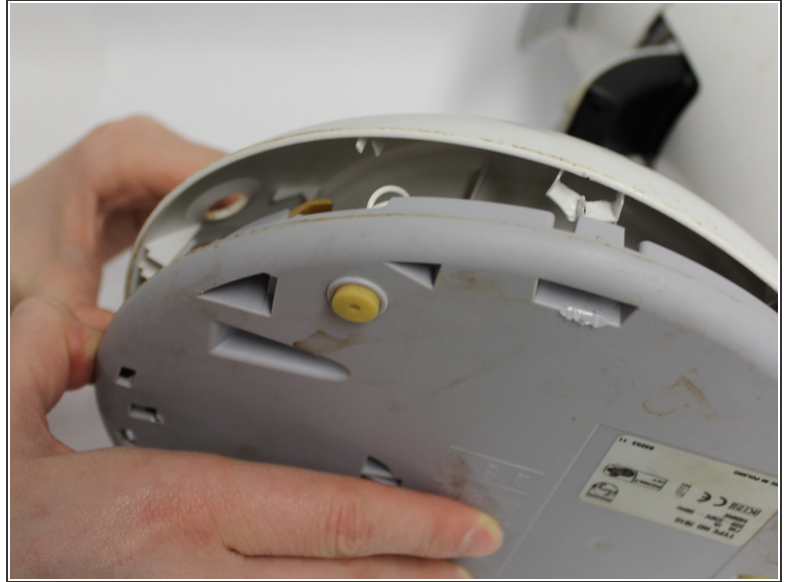
Step 7

- Tilt the coffee machine and disconnect the bottom housing by pressing a flathead screwdriver against the snap-fit (CAUTION). There is a total of 6 snap-fits. (Two snap-fits at the rear are not visible in the picture)
- ⚠ Beware of not applying too much force when pressing snap-fits to avoid bending (and breaking) during the repair.

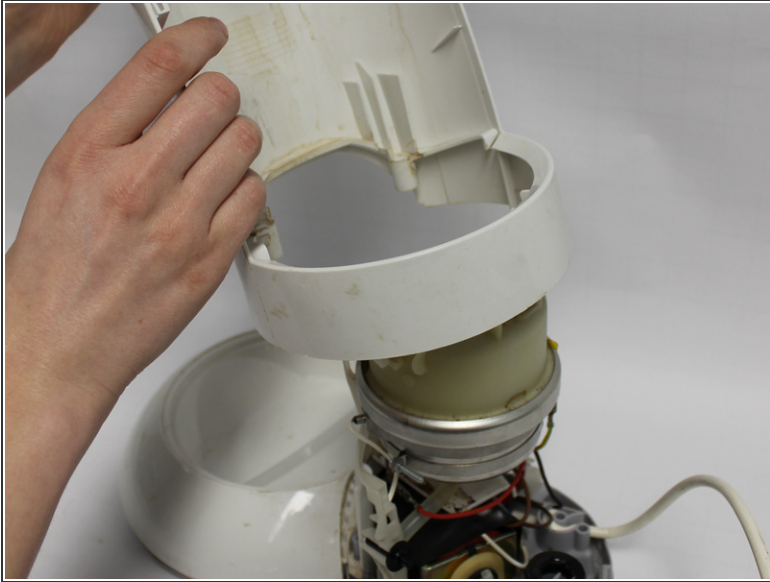
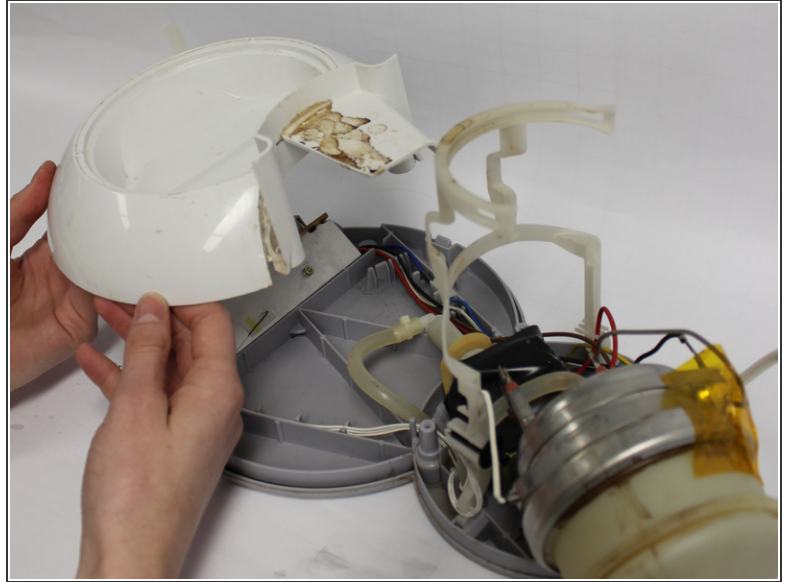
Step 8

- Remove the cylindrical housing from the bottom housing.
- Remove the cup tray housing from the bottom housing.

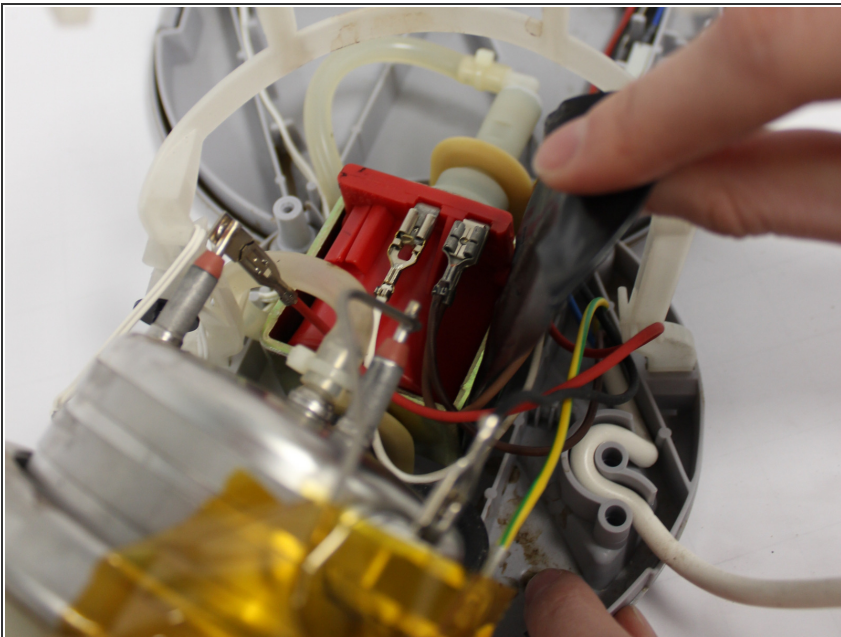
Step 9

- Remove the tape from the red pump, by pulling.
- ⚠ Leaving the tape attached on the right side, enables re-using of the tape when reassembling.

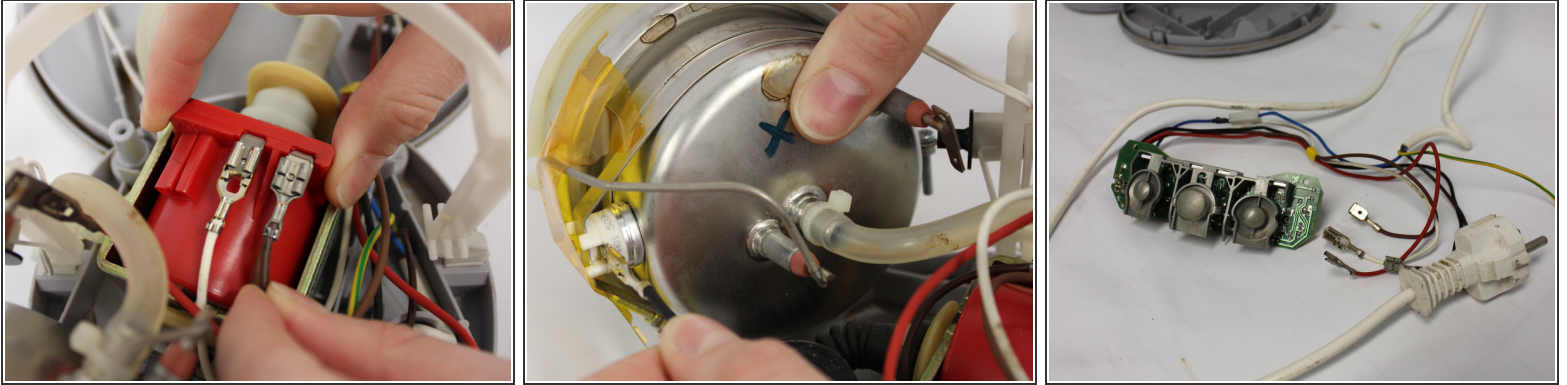
Step 10

- Disconnect the two cables (white-brown) from the red pump by pulling gently. If the cables are hard to remove, carefully use flat nose pliers to pull the cables.
- ⚠ Remember the position of the cables for reassembling the Senseo machine. Marking the location and the cable with a different color marker, can be a solution.
- Disconnect the red, blue and green/yellow cables from the boiler.
- ⚠ Remember the position of the cables for reassembling the Senseo machine. Marking the location and the cable with a different color marker, can be a solution.

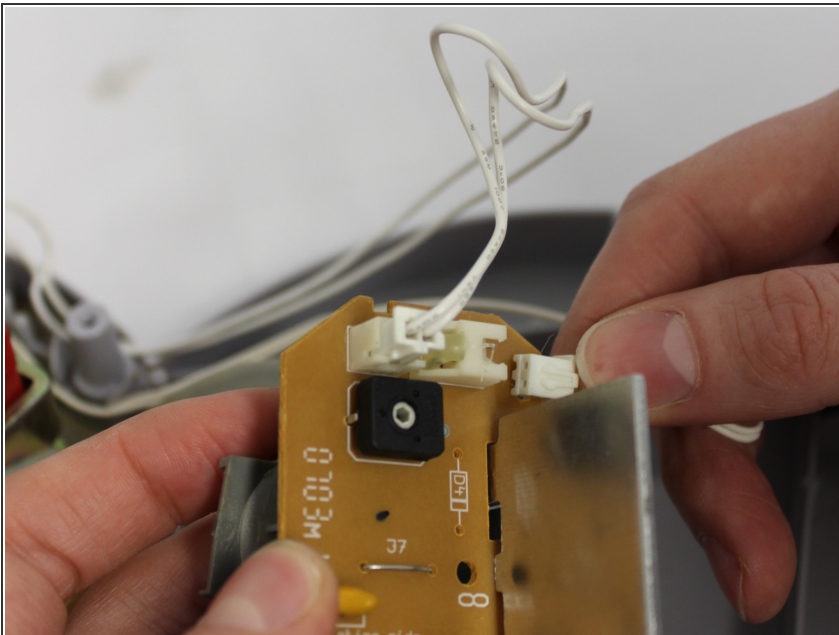
Step 11

- Remove the two white cables, so the printboard (PCB) is no longer connected to the internal components.
- ⚠ Remember the position of the cables for reassembling the Senseo machine. Marking the location and the cable with a different color marker, can be a solution.

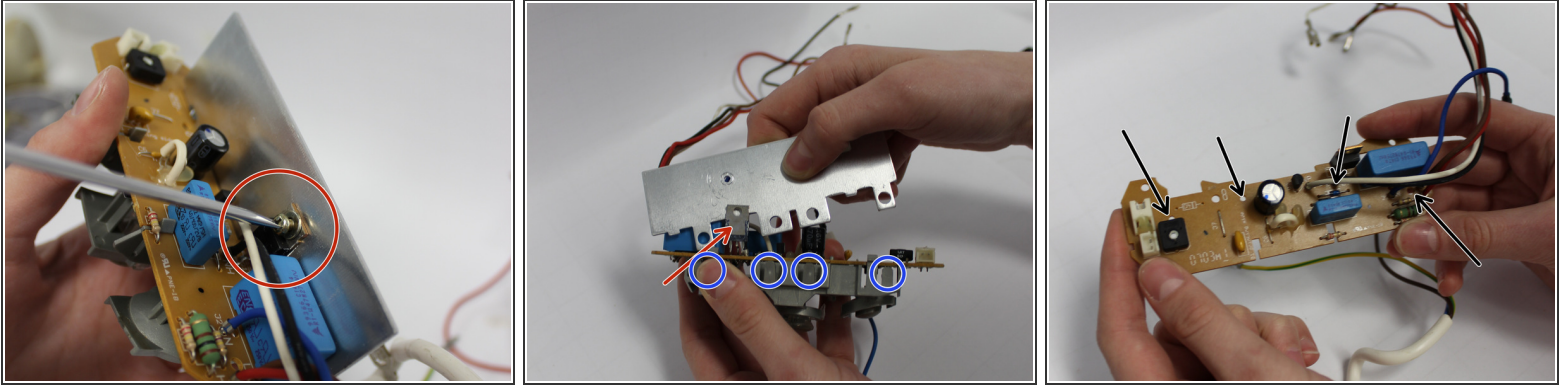
Step 12

- Remove the nut from the plate against the PCB, using a Phillips screwdriver.

⚠ The order of loosening the snapfits now is important. First carefully press out (in an upward direction) four click fingers (from plastic buttons) that hold the plate in place, and then push out four pins in the PCB (holes marked with black arrows), which loosens the buttons. Beware of not affecting the transistor integrity when removing the plate.

- Remove the snap-fits of the PCB, so the plate and the PCB can be disconnected. Use a flathead screwdriver for punching and sculling.

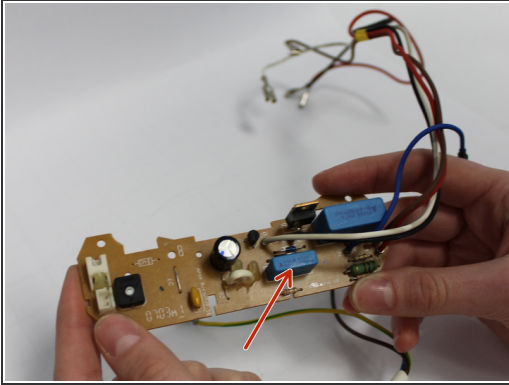
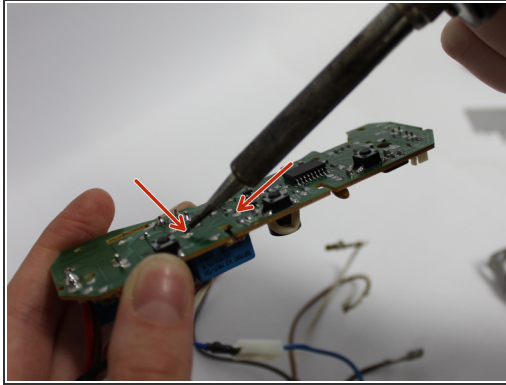
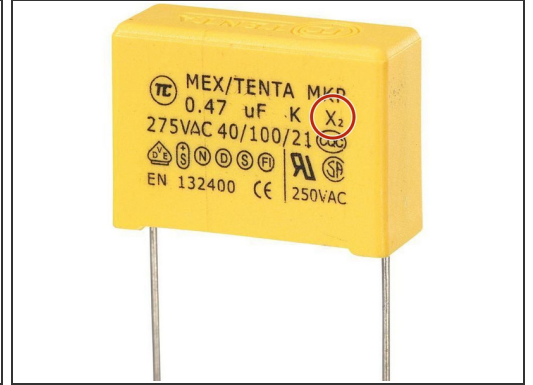
Step 13

- i Obvious characteristics of a damaged capacitor are leakage of a brownish fluid, corrosion, or severed leads. Non-obvious signs could be measured with a capacity gauge (for the professional handyman).
- Search for the pegs of the capacitor on the PCB and warm up the soldering iron. Remember orientation (left-right)!
- ★ The capacitor specification should be: 470nF, min. 275 VAC, 22.5 mm pitch. Only use X2-Class qualification which can be distinguished on the part. Capacitors come in blue and yellow colors.
- ! Caution: the soldering iron will be hot. Perform this action in a well-ventilated area.

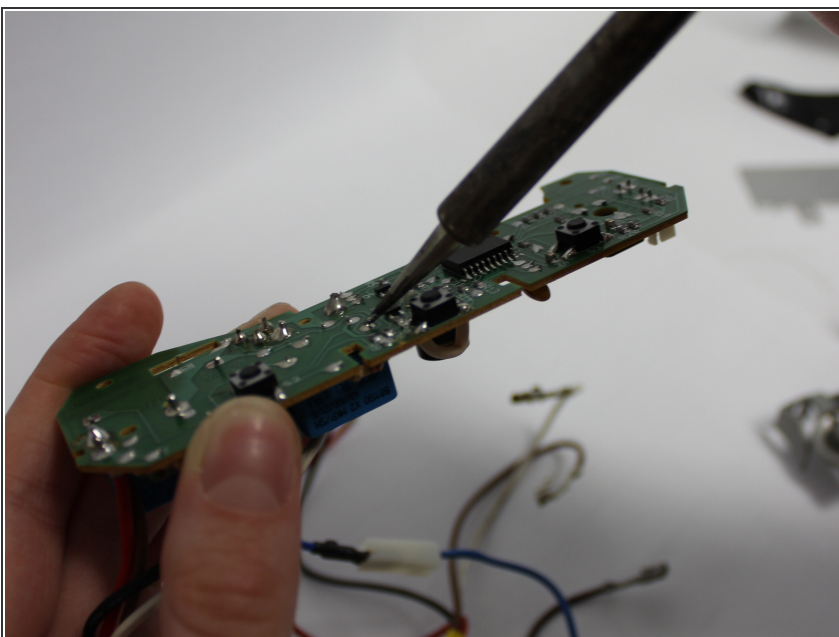
Step 14

- Loosen the capacitor of the PCB, by desoldering the tin spots using the iron and remove the capacitor from the PCB.
- ! Caution: the soldering iron will be hot. Do not breath the soldering fumes. They are toxic. Perform this action in a well-ventilated area.

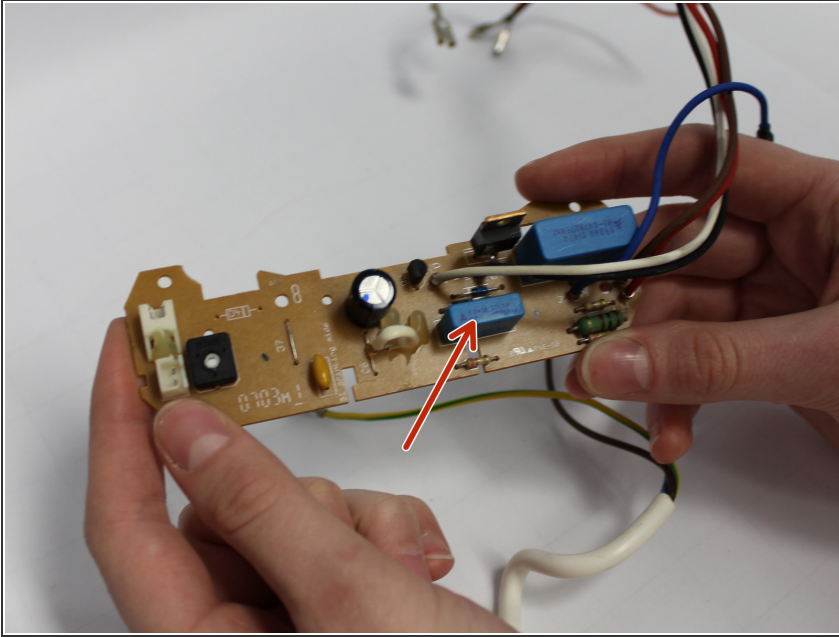
Step 15

- Replace the capacitor by soldering a new capacitor of the same type on the exact same spot:
- scratch the green plastic of the printboard (with flathead screwdriver) to improve conductivity and cohesion;
- keep the capacitor on the right spot, hold the tin against the pegs of the capacitor and heat the tin with the soldering iron. The tin will cool down and the capacitor will be fixed.

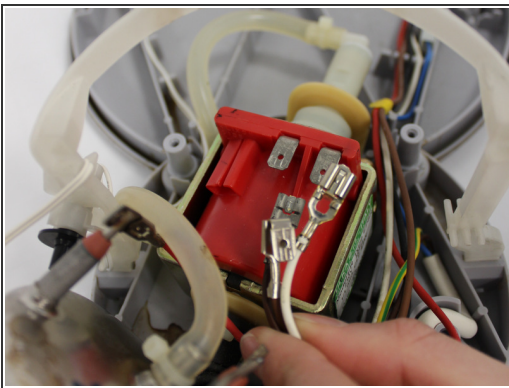
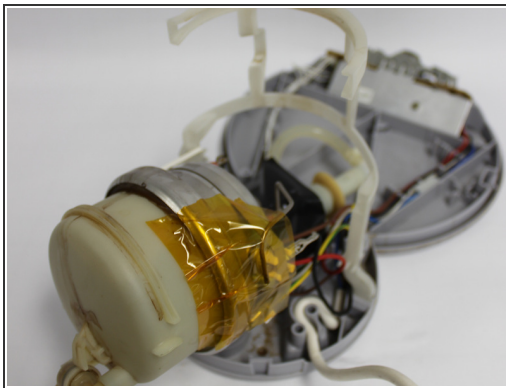
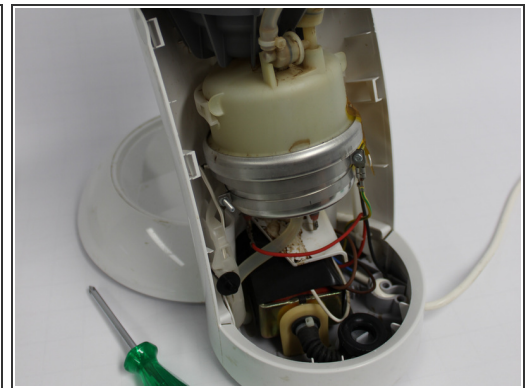
Step 16

- Reassemble the Senseo coffee maker. The suggested actions during the disassembly should now help you greatly. Be careful with connecting wires (in the right way), tilting and reconnecting the boiler, and closing the housings and snap-fits.
